Stronger collision protection for buses: Change of ECE-66 and ECE-R107

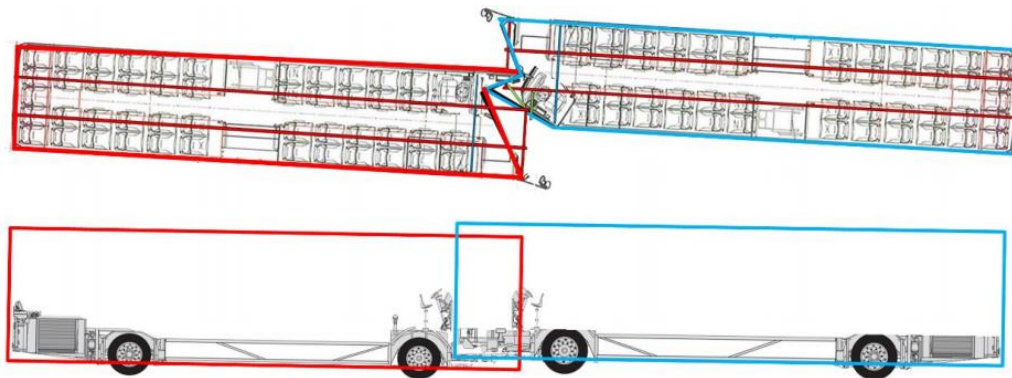
A head-on collision between two class II buses occurred in Norway in November 2017. The Volvo 8700 buses, 2009-models, fulfilled ECE-regulations. The drivers' cabins of both buses were severely deformed, even though the collision happened with respective speeds of 33 and 34 km/h at the time of impact. The front of each bus penetrated the other by about one meter. One driver was killed instantly, the other was critically injured in the accident. Illustration of accident between the Volvo-buses, [page 10 in AIBN-report](#):

The Accident Investigation Board of Norway (AIBN) concludes that the extent of the accident was affected by low collision safety. [Their report](#) documents the need for stronger collision protection for buses. This includes both the drivers' cabin and at the front of the bus. There was also a similar accident with fatal outcome in Finland in 2015 and another accident between a class III bus and a goods vehicle in Norway in 2014. The ECE-requirements for protection are less stringent for buses than for cars and trucks.

- Improvement of collision protection at drivers' cabin for buses of class I, II and III.
- Improvement of collision protection in the front of the bus, minimum as for trucks (most important for class II and III buses).

Changes in ECE-66 and ECE-R107 will include all manufacturers, requiring all to implement satisfactory technical solutions, with the greatest effect to prevent fatal outcomes in future head-on collisions. The bus driver and the truck driver should have equally safe workplaces.

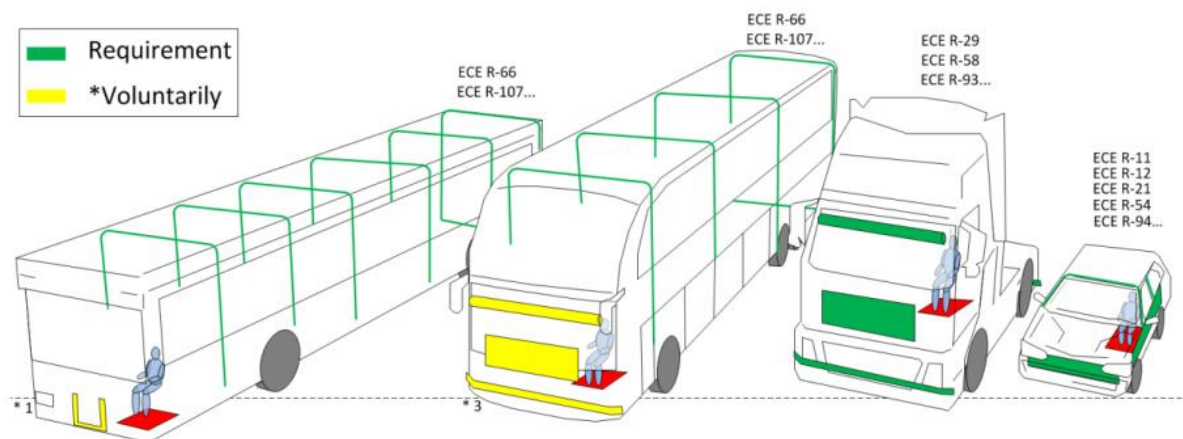
Illustration of collision protection requirements for various vehicle groups:

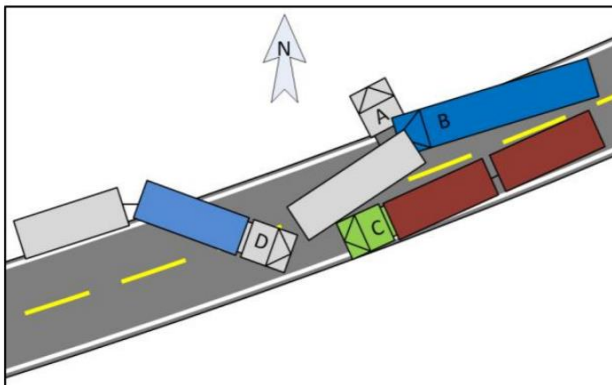
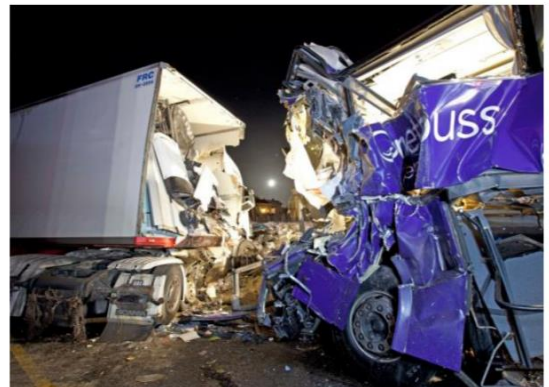
- Example of collision between a bus and a goods vehicle in Norway February 2014 (illustration from investigation [report](#)):

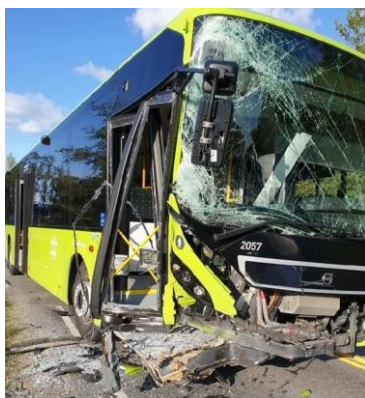
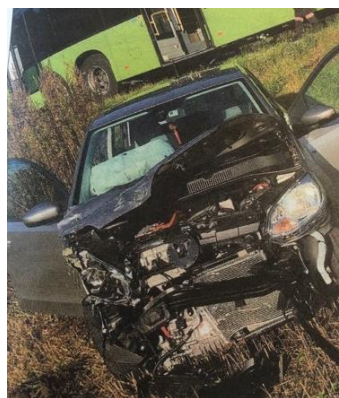
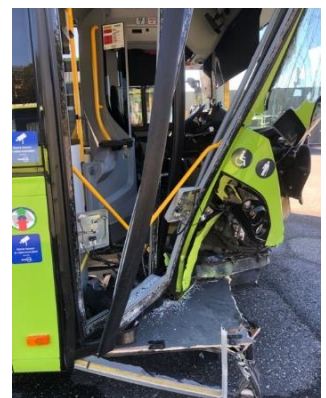
- Example of collision between a car and a bus in Norway September 2019 (Volkswagen Up! and Volvo 8900):
